Sample from Schedule of Condition

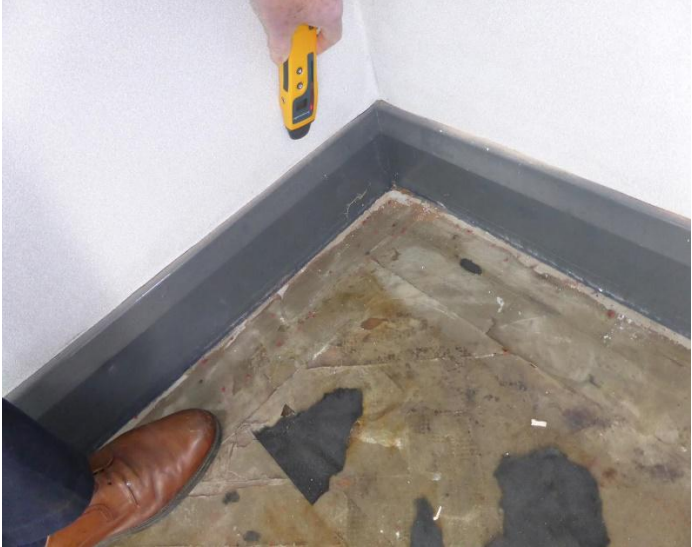
<p>147</p>	<p>Description General office/former banking hall - front wall and floors</p> <p>Condition Poor</p> <p>Moisture meter readings provide evidence of moderate rising dampness to front wall with associated added plasterwork. Moderate soiling to woodblock floor from carpet adhesive. Areas of wet rot to timber skirting.</p>

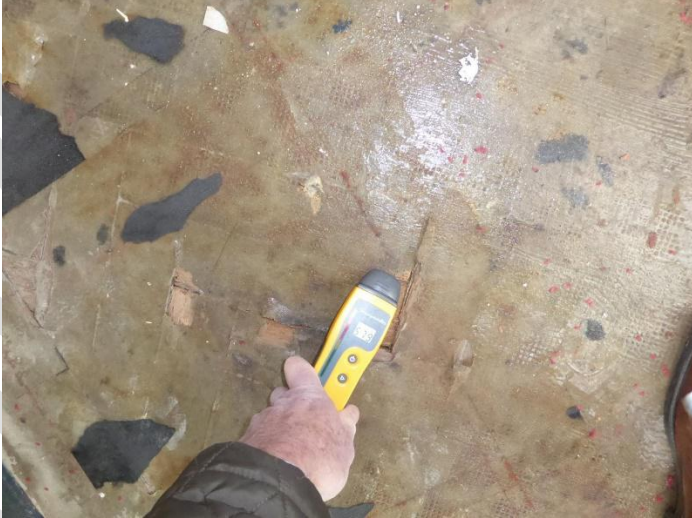
<p style="text-align: center;">0120</p>
<p>148</p>	<p>Location/Element</p> <p>Description General office/former banking hall - floors</p> <p>Condition Poor</p> <p>Evidence of significant rising dampness through majority of woodblock flooring. Moderate soiling to woodblock floor from carpet adhesive.</p>

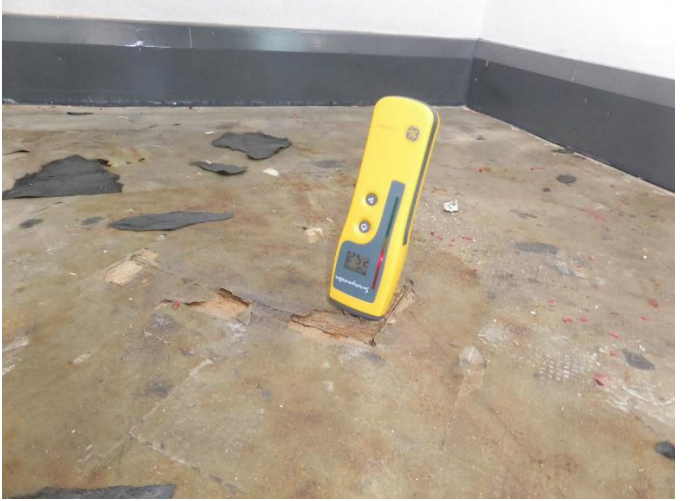
<p style="text-align: center;">0121</p>
<p>149</p>	<p>Location/Element</p> <p>Description General office/former banking hall - floors</p> <p>Condition Poor</p> <p>Evidence of significant rising dampness and severe wet rot to woodblock flooring.</p>
